NRL Memorandum Report 6969

Date: 15 June 1992

Non-Metallic Transducer  
Mounting Brackets  
(AN/BQQ-5/6 Spherical  
Array Transducers)

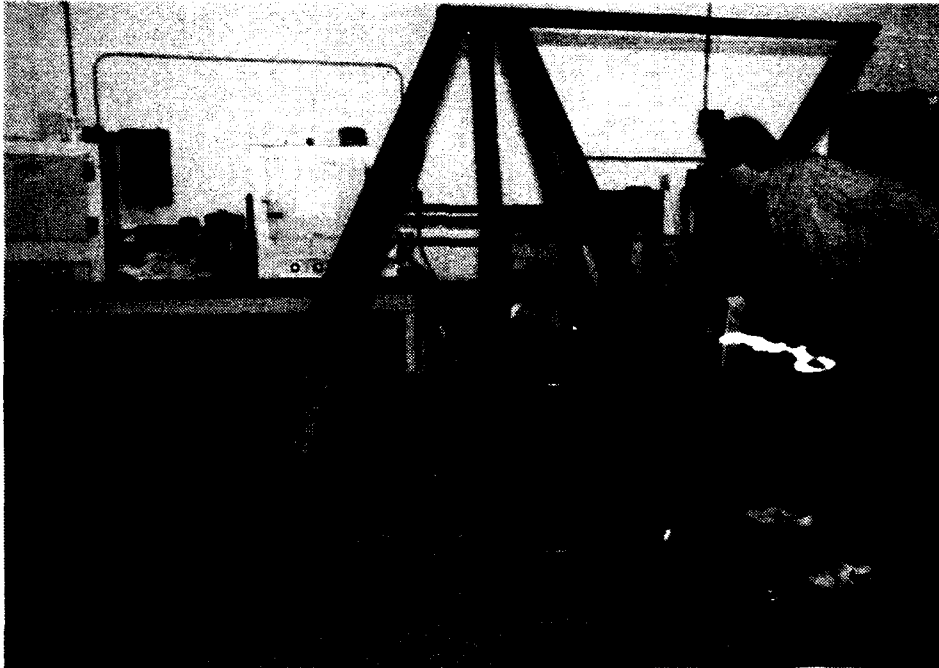
**Fig. 66 – ITM in operation**

Figure 66 is a photograph of the test machine in operation, and Fig. 67 is a photograph of the pendulum arm just prior to impact. Figures 68 and 69 show the shock signature of an ITM run with the Al-Br bracket at an impact velocity of 3 m/s (9.9 ft/s). Peak hammer accelerations from the bracket saw approximately 340 g's. Figures 70 and 71 show an example of the Vectra A-515 bracket material impact signatures at position 6 which attains an impact velocity of 3.6 m/s (11.7 ft/s).

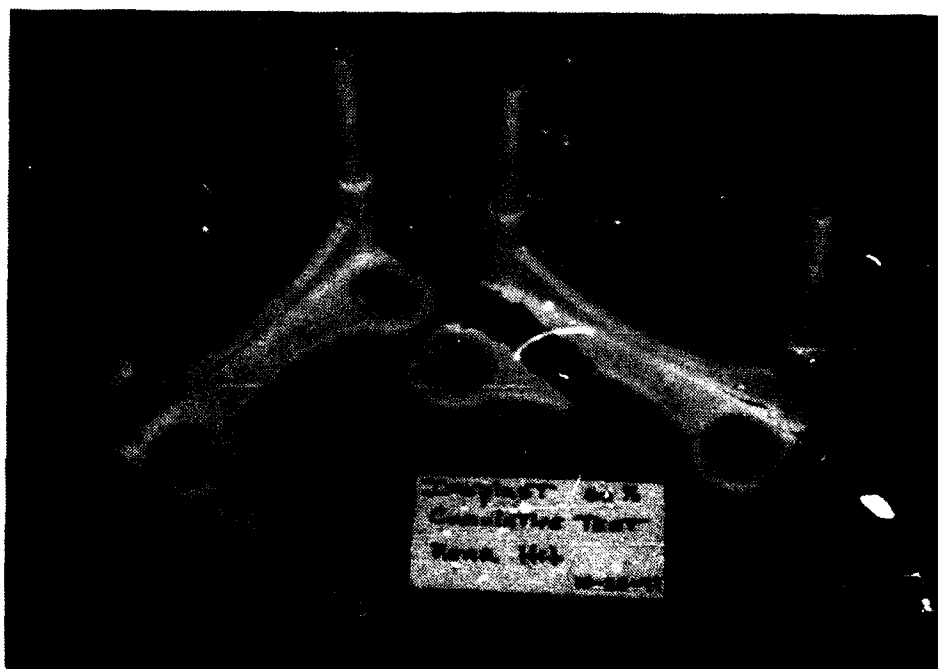
**Fig. 75 - Cumulative impact damage on Isoplast 60% glass unmodified TR-317 brackets (impact on transducer tail assembly)**

TR-317 standard brackets. The cumulative impact tests are performed by releasing the ITM hammer from increasingly higher height positions until failure of the bracket or the maximum height position on the ITM is reached. Table 8 presents the results of the cumulative impact tests on the TR-317 standard brackets with the impact occurring on the transducer headmass. This impact orientation represents the explosive shock experienced by the brackets in an actual submarine sonar dome installation. Table 9 shows the same results with the impact occurring on the tail assembly of the transducer. This impact orientation represents the explosive shock experienced by the brackets during a MIL-S-901-D explosive shock test. The results from these tests show that the Isoplast and Vectra materials are the most impact resistant and were chosen for explosive shock testing. Note that the MIL-S-901-D explosive shock test orientation (impact on transducer tail assembly) is a more severe impact test of the TR-317 brackets than installation in a submarine sonar dome. Figures 72 and 73 show cumulative impact damage sustained by the Isoplast material with 40% glass. Figures 74 and 75 show impact damage sustained by the 60% glass Isoplast. Figures 76 and 77 document the impact damage sustained by the Vectra material. Figure 78 shows a comparison of the cumulative impact damage on the Al-Br brackets with an untested bracket. Note the bending of the bracket posts on the damaged bracket.

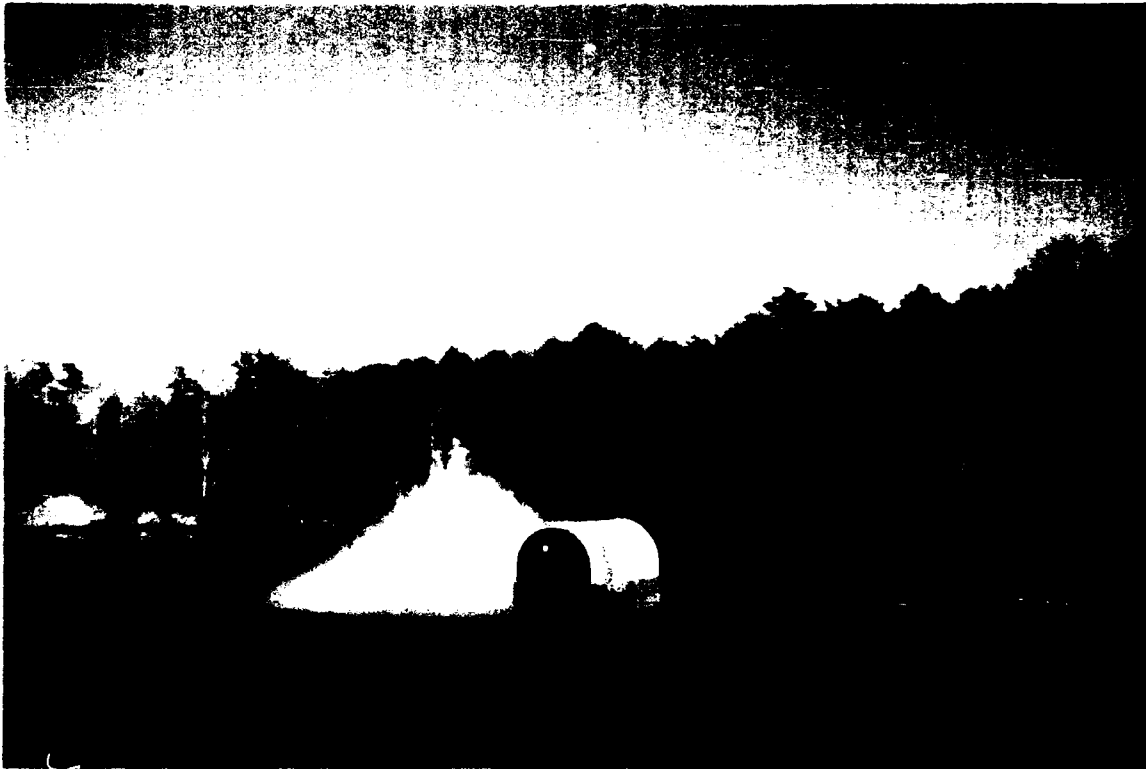
**Fig. 86 – Start of explosive shock test shot #4 at the HI-Test shock test facility**

Figures 86 and 87 illustrate the explosive shock test progression for shot #4 at the HI-Test explosive shock test facility. After each shot the barge was lifted out of the water and a visual inspection was made of the test fixture. All of the non-metallic brackets survived the test series. Initial visual examination after shot #4 showed no visible surface damage to any of the non-metallic brackets. A more extensive visual examination was made at TRI/Austin. Figure 88 shows the brackets after testing, laid out in the test matrix configuration. The only visible damage to the non-metallic brackets was a surface crack on the Vectra brackets located on the molding knit line formed at the holes in the bracket flange. See Fig. 89. A portion of the rubber shock isolation grommet was pinched in the crack indicating that the crack was opened up allowing the rubber to be pushed into the crack and then closed rapidly trapping the rubber material. These surface cracks appear to be present only in the hard liquid crystal polymer skin that forms during the molding of the Vectra material. Since the cracks formed only at the knit line it seems likely the cracking is due to a molding problem with the Vectra material. The presence of these surface cracks are minor in nature and did not result in a part failure.

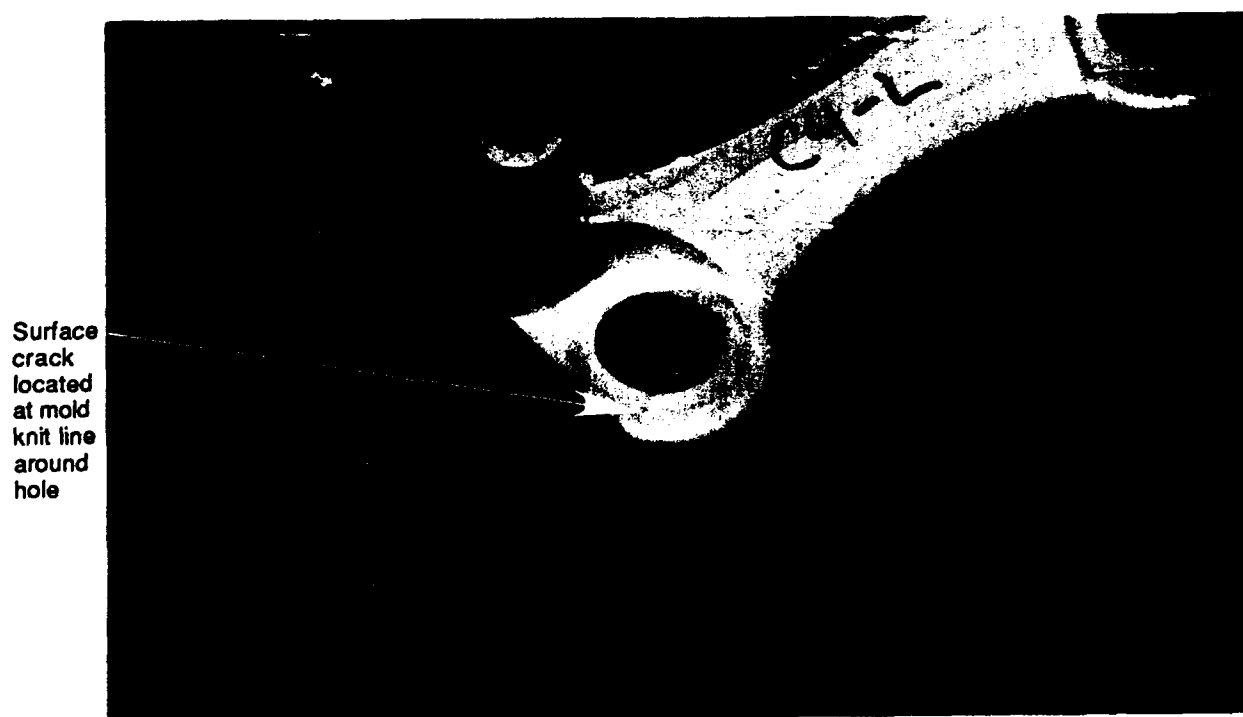
**Fig. 89 – Example surface crack found on Vectra brackets after explosive shock testing**
